Site Name: Vasquez Boulevard / Interstate 70 Superfund Site - Brighton Blvd
 Other Site Name(s): National Western Center Redevelopment Project

Site Location: National Western Complex near Brighton Boulevard and 47th Avenue
 (Street)
1 Denver Denver CO 80216 +
 Congressional District (City) (County) (State / Terr) (Zip+4)

Appendix 1 - Pre-CERCLA Screening
VB/I-70, Brighton Blvd., Denver
July 2019

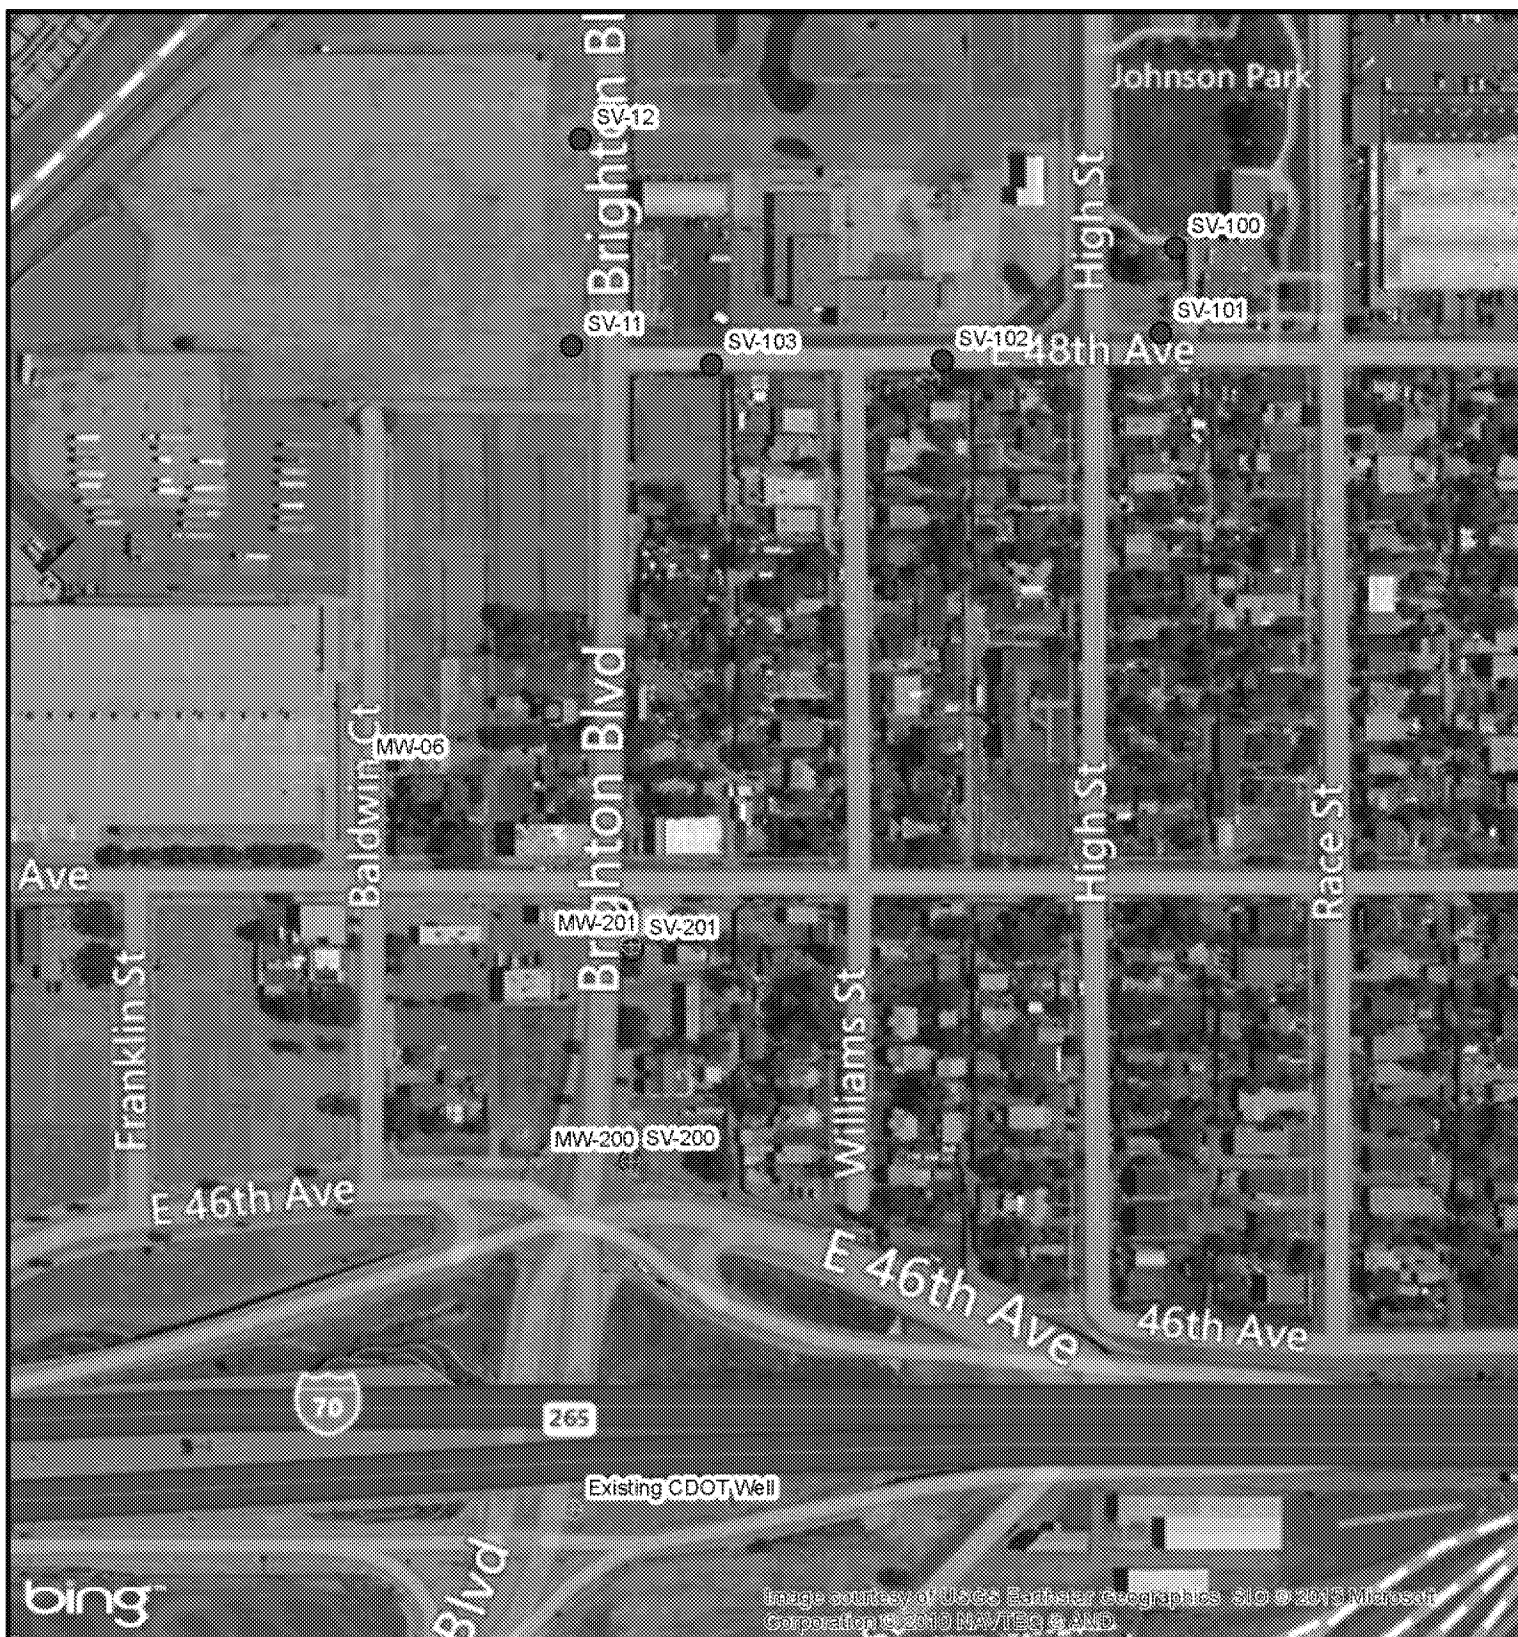
<div> <div>N</div> <div> <div>⊕</div> <div>Monitoring Well Locations</div> </div> <div> <div>●</div> <div>Soil Vapor Locations</div> </div> </div> <div> <div>0</div> <div>150</div> <div>300</div> <div>Feet</div> </div>		<div> <div>Pinyon</div> <div>MONITORING LOCATIONS</div> <div>National Western Stock Show</div> <div>Denver, Colorado</div> </div>	
<div>Site Location: Sections 14 & 23, T 3S , R 68W, 6th Principal Meridian</div>		<div>Drawn By: JAF</div>	<div>Figure: 2</div>
<div>Pinyon Project Number: 1/15-007-10.2002</div>		<div>Reviewed By: JRC</div>	<div>Date: 10/1/2015</div>
